## **MARINE INVESTIGATION REPORT**

**M99W0033**

**NEAR-CAPSIZING**

**THE SMALL FISHING VESSEL "WESTISLE"  
OFF CAPE BEALE, BRITISH COLUMBIA  
1 MARCH 1999**

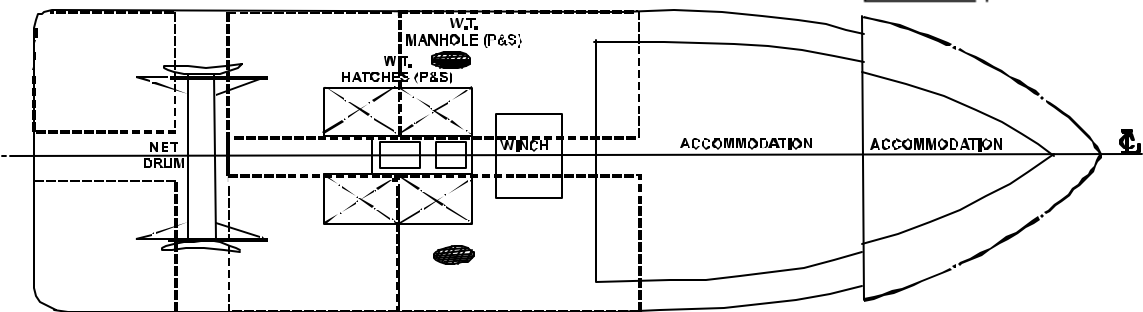
MAIN DECK

3. While working in the seaway, the improperly secured flush-fitting deck scuttle cover of the forward starboard cargo tank became dislodged. Thus, the compartment's watertight integrity was lost.

4. The deck scuttle covers were neither hinged nor secured by a chain to the vessel's structure.
5. The vessel developed a starboard list when seawater down flooded through the improperly secured and subsequently dislodged flush-fitting deck scuttle cover.

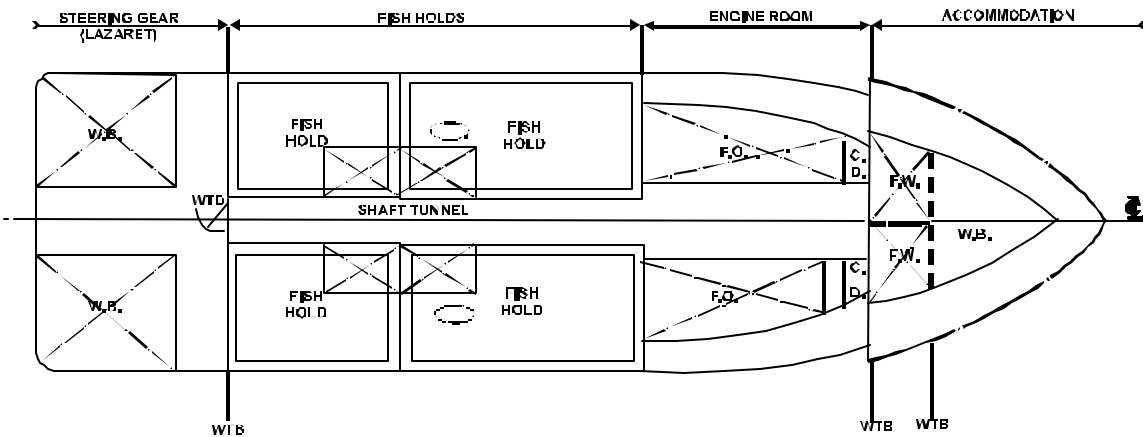
TANKS, HOLDS & ENGINE ROOM

In this instance, the adverse free surface effects progressively increased as the situation developed. The initial free surface effect was created when the four cargo tanks were partially filled with liquid cleaning agent prior to the vessel's departure. When the forward starboard cargo tank's watertight integrity was lost, the amount of water in the compartment progressively increased as seawater down flooded through the unsecured (and subsequently dislodged) deck scuttle cover. This caused the vessel's starboard list to progressively increase. As the list increased, the freeing ports became immersed and a larger amount of seawater was shipped and retained on the deck. The dangerous situation was further compounded when the unsecured deck cargo shifted to starboard and the starboard deck edge remained submerged. The vessel's inherent transverse stability characteristics and remedial action taken by the crew prevented more serious consequences to the occurrence.
